Radiograph Interpretation - Welds

In addition to producing high quality radiographs, the radiographer must also be skilled in radiographic interpretation. Interpretation of radiographs takes place in three basic steps which are (1) detection, (2) interpretation, and (3) evaluation. All of these steps make use of the radiographer's visual acuity. Visual acuity is the ability to resolve a spatial pattern in an image. The ability of an individual to detect discontinuities in radiography is also affected by the lighting condition in the place of viewing, and the experience level for recognizing various features in the image. The following material was developed to help students develop an understanding of the types of defects found in weldments and how they appear in a radiograph.

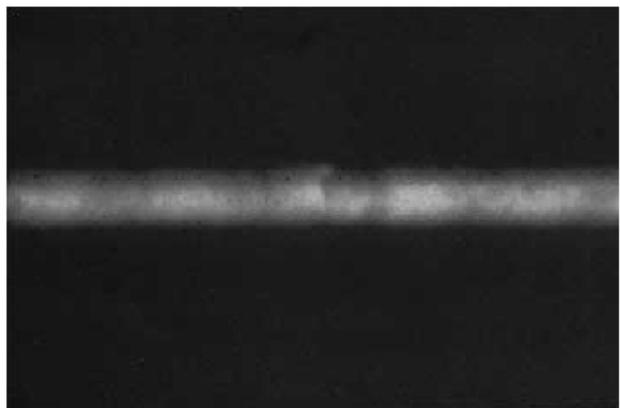
Cold lap is a condition where the weld filler metal does not properly fuse with the base metal or the previous weld pass material (interpass cold lap). The arc does not melt the base metal sufficiently and causes the slightly molten puddle to flow into base material without bonding.

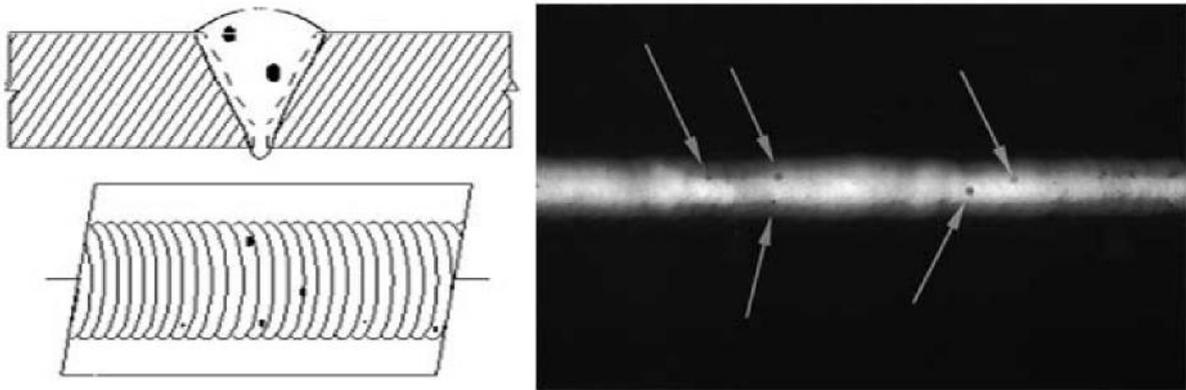
Porosity is the result of gas entrapment in the solidifying metal. Porosity can take many shapes on a radiograph but often appears as dark round or irregular spots or specks appearing singularly, in clusters or rows. Sometimes porosity is elongated and may have the appearance of having a tail This is the result of gas attempting to escape while the metal is still in a liquid state and is called wormhole porosity. All porosity is a void in the material it will have a radiographic density more than the surrounding area.

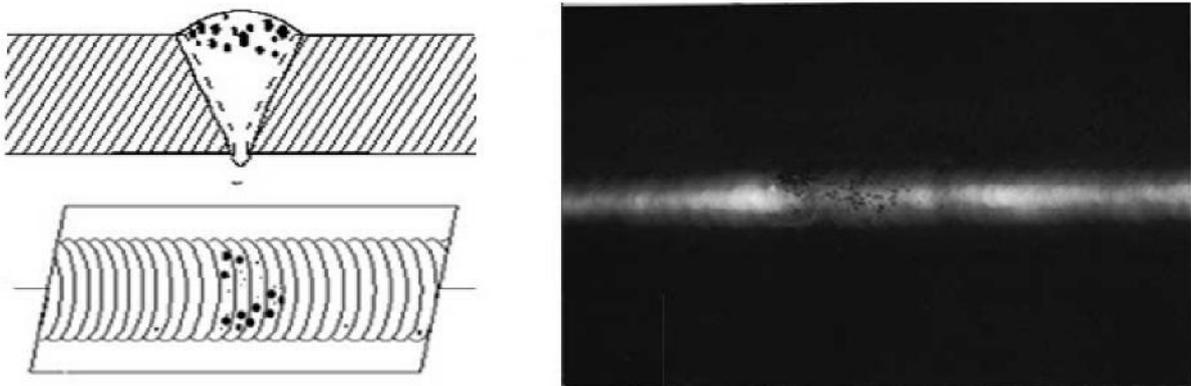
Cluster porosity is caused when flux coated electrodes are contaminated with moisture. The moisture turns into gases when heated and becomes trapped in the weld during the welding process. Cluster porosity appear just like regular porosity in the radiograph but the indications will be grouped close together.

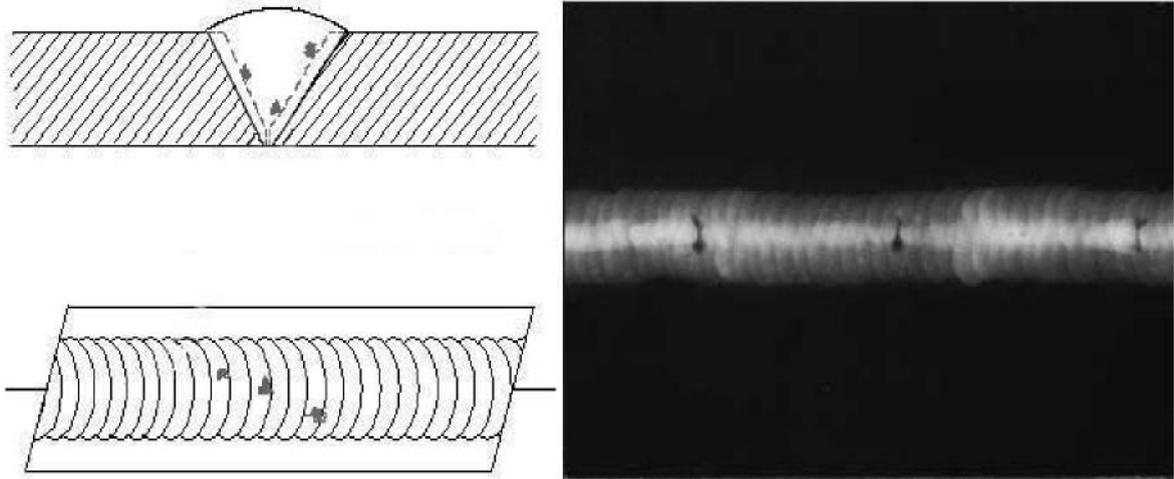
Slag inclusions are nonmetallic solid material entrapped in weld metal or between weld and base metal. In a radiograph, dark, jagged asymmetrical shapes within the weld or along the weld joint areas are indicative of slag inclusions.

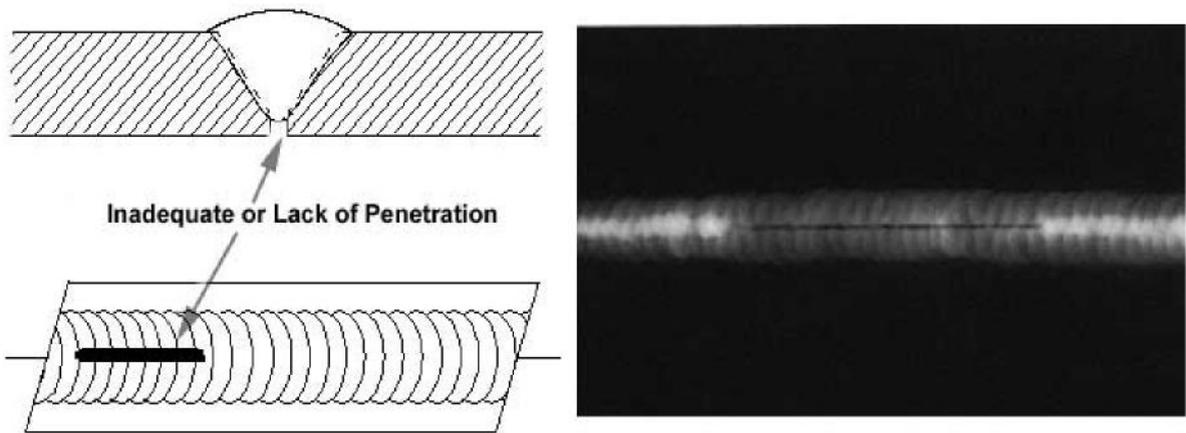
Incomplete penetration (IP) or lack of penetration (LOP) occurs when the weld metal fails to penetrate the joint. It is one of the most objectionable weld discontinuities. Lack of penetration allows a natural stress riser from which a crack may propagate. The appearance on a radiograph is a dark area with well-defined, straight edges that follows the land or root face down the center of the weldment.

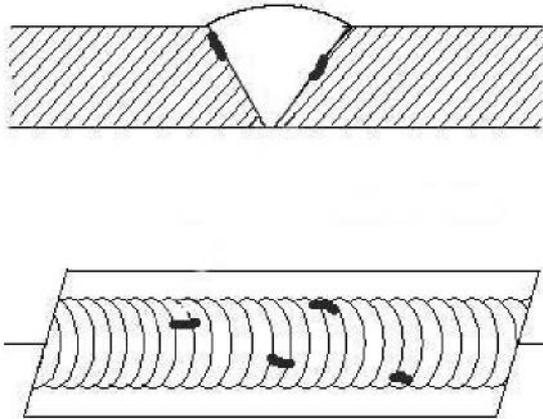
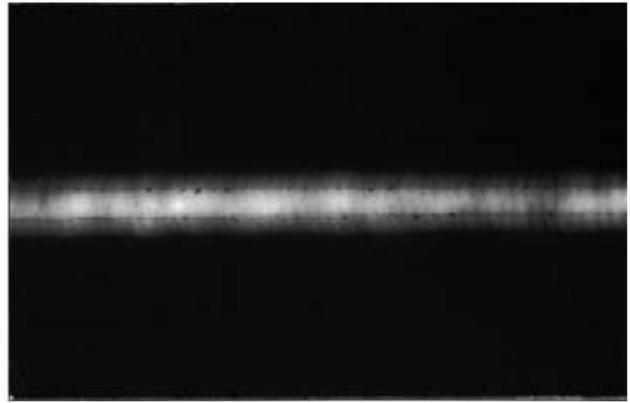
Incomplete fusion is a condition where the weld filler metal does not properly fuse with the base metal. Appearance on radiograph: usually appears as a dark line or lines oriented in the direction of the weld seam along the weld preparation or joining area.

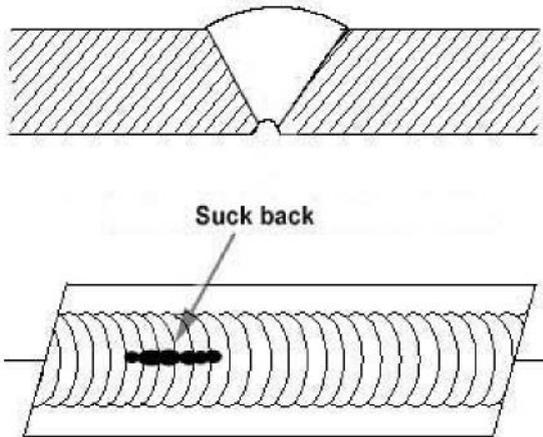
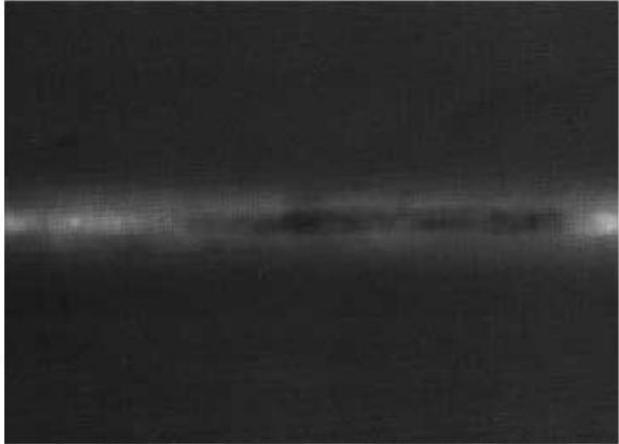
Internal concavity or suck back is condition where the weld metal has contracted as it cools and has been drawn up into the root of the weld. On a radiograph it looks similar to lack of penetration but the line has irregular edges and it is often quite wide in the center of the weld image.

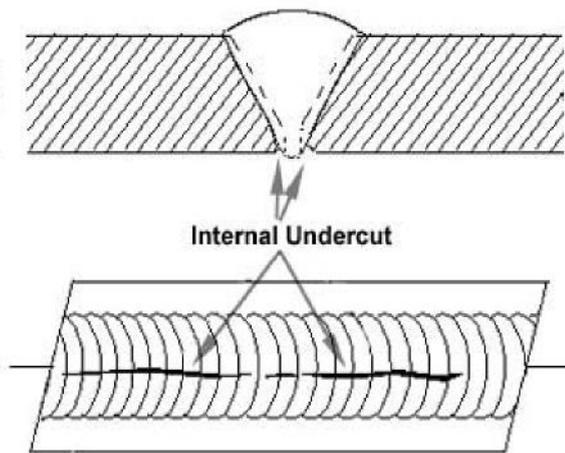
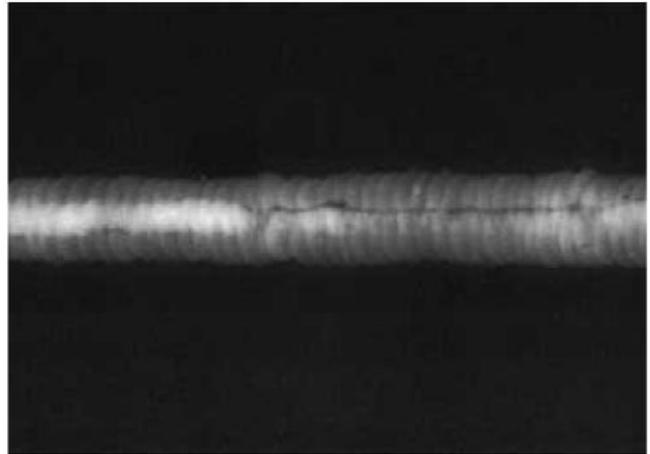
Internal or root undercut is an erosion of the base metal next to the root of the weld. In the radiographic image it appears as a dark irregular line offset from the centerline of the weldment. Undercutting is not as straight edged as LOP because it does not follow a ground edge.

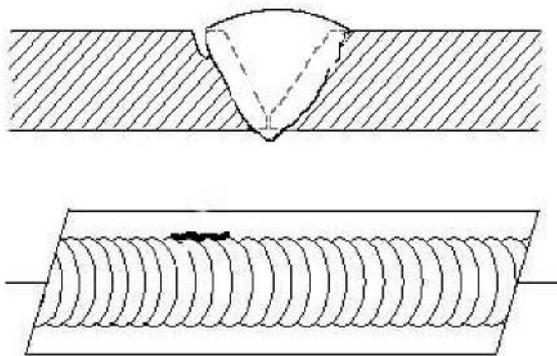
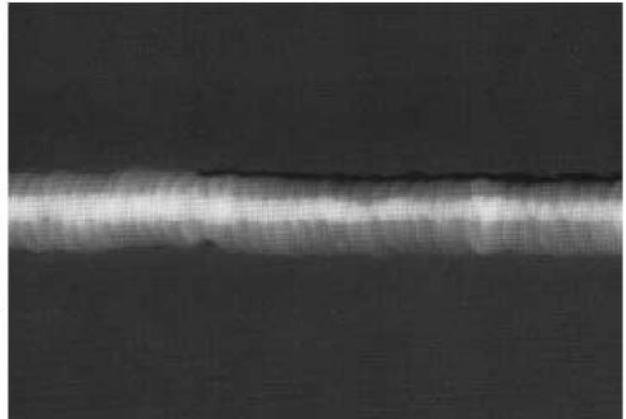
External or crown undercut is an erosion of the base metal next to the crown of the weld. In the radiograph, it appears as a dark irregular line along the outside edge of the weld area.

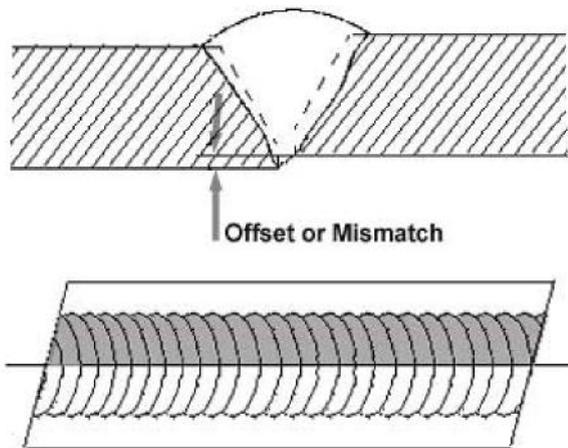
Offset or mismatch are terms associated with a condition where two pieces being welded together are not properly aligned. The radiographic image is a noticeable difference in density between the two pieces. The difference in density is caused by the difference in material thickness. The dark, straight line is caused by failure of the weld metal to fuse with the land area.

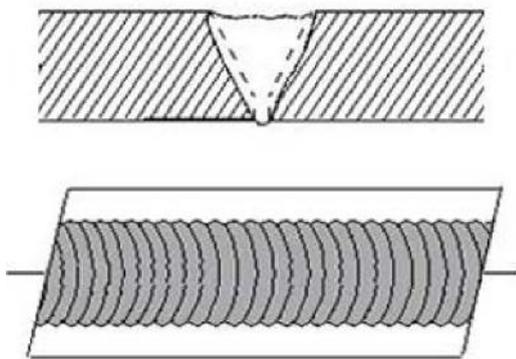
Inadequate weld reinforcement is an area of a weld where the thickness of weld metal deposited is less than the thickness of the base material. It is very easy to determine by radiograph if the weld has inadequate reinforcement, because the image density in the area of suspected inadequacy will be more (darker) than the image density of the surrounding base material.

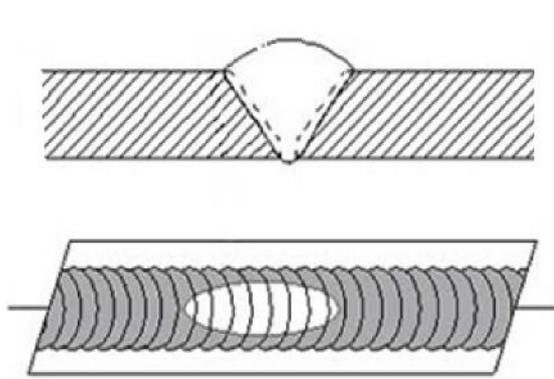
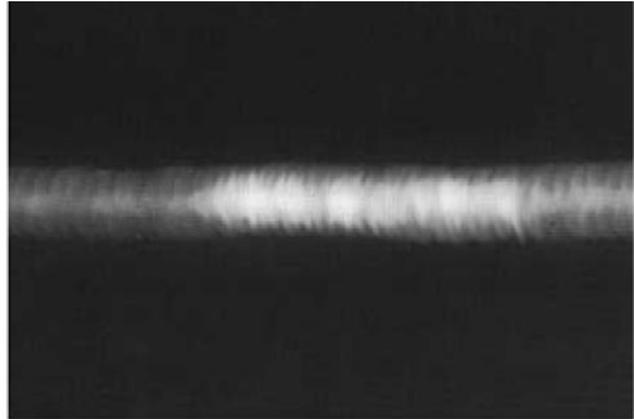
Excess weld reinforcement is an area of a weld, which has weld metal added in excess of that specified by engineering drawings and codes. The appearance on a radiograph is a localized, lighter area in the weld. A visual inspection will easily determine if the weld reinforcement is in excess of that specified by the individual code involved in the inspection.

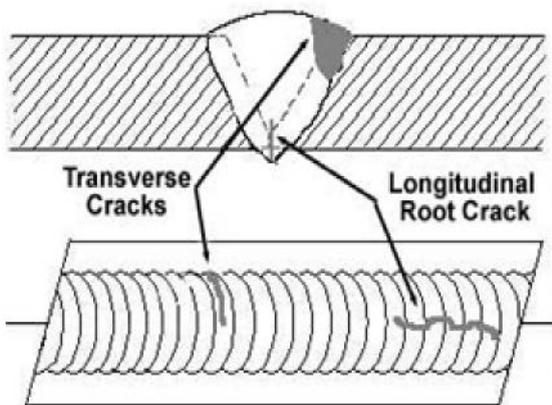
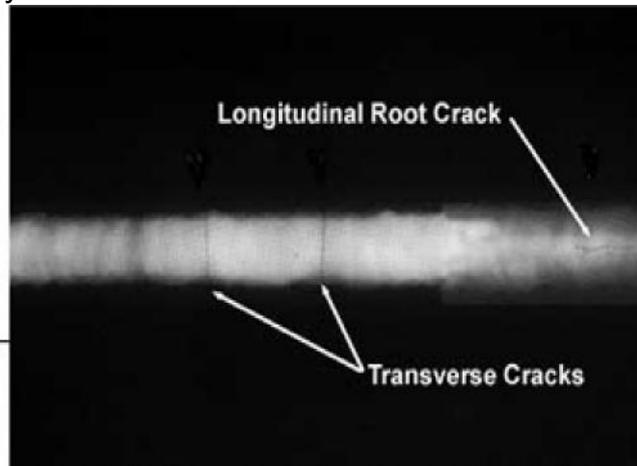
Cracking can be detected in a radiograph only the crack is propagating in a direction that produced a change in thickness that is parallel to the x-ray beam. Cracks will appear as jagged and often very faint irregular lines. Cracks can sometimes appear as "tails" on inclusions or porosity.

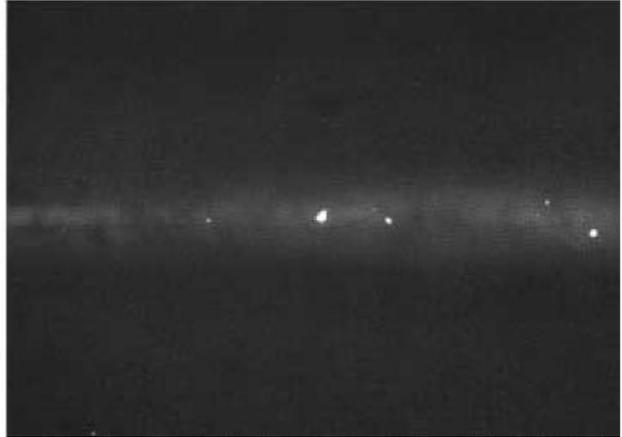
Tungsten inclusions. Tungsten is a brittle and inherently dense material used in the electrode in tungsten inert gas welding. If improper welding procedures are used, tungsten may be entrapped in the weld. Radiographically, tungsten is more dense

than aluminum or steel; therefore, it shows as a lighter area with a distinct outline on the radiograph.

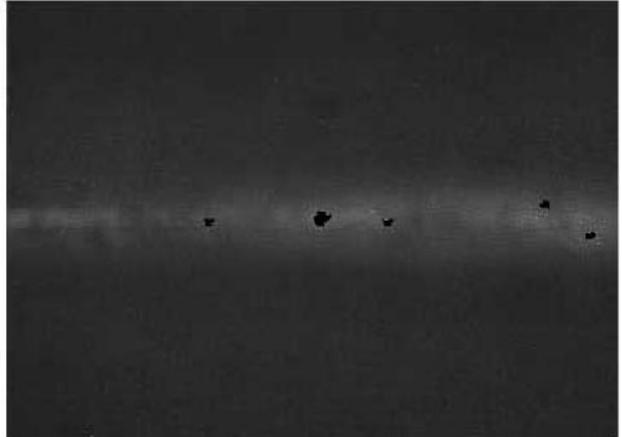
Oxide inclusions are usually visible on the surface of material being welded (especially aluminum). Oxide inclusions are less dense than the surrounding materials and, therefore, appear as dark irregularly shaped discontinuities in the radiograph.

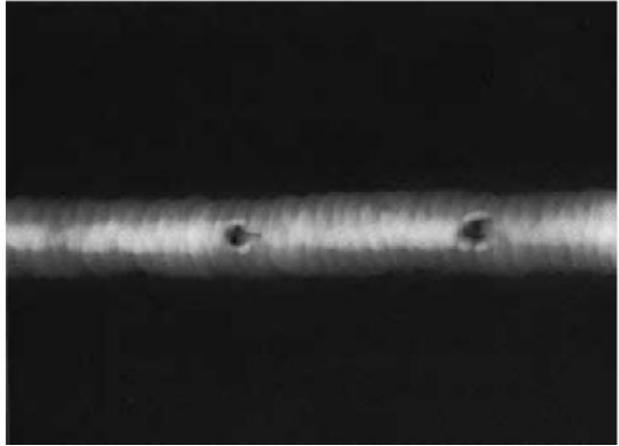
Burn through (icicles) results when too much heat causes excessive weld metal to penetrate the weld zone. Lumps of metal sag through the weld creating a thick globular condition on the back of the weld. On a radiograph, burn through appears as dark spots surrounded by light globular areas.
